DEPARTMENT OF TRANSPORTATION

Contract #: 04-0120F4Cty: SF/ALA Rte: 80 PM: 13.2/13.9File #: 69.28**WELDING INSPECTION REPORT****Resident Engineer:**Siegenthaler, Peter**Address:** 333 Burma Road**City:** Oakland, CA 94607**Report No:** WIR-025033**Date Inspected:** 20-May-2011**Project Name:** SAS Superstructure**OSM Arrival Time:** 1500**Prime Contractor:** American Bridge/Fluor Enterprises, a JV**OSM Departure Time:** 300**Contractor:** Zhenhua Port Machinery Company, Ltd (ZPMC), Changxing Island **Location:** Shanghai, China**CWI Name:** Mr. Li Yan Hua**CWI Present:** Yes No**Inspected CWI report:** Yes No N/A**Rod Oven in Use:** Yes No N/A**Electrode to specification:** Yes No N/A**Weld Procedures Followed:** Yes No N/A**Qualified Welders:** Yes No N/A**Verified Joint Fit-up:** Yes No N/A**Approved Drawings:** Yes No N/A**Approved WPS:** Yes No N/A**Delayed / Cancelled:** Yes No N/A**Bridge No:** 34-0006**Component:** OBG**Summary of Items Observed:**

WELDING INSPECTION REPORT

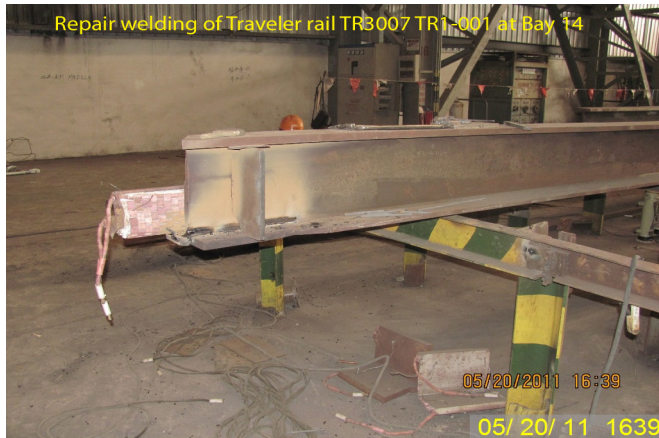
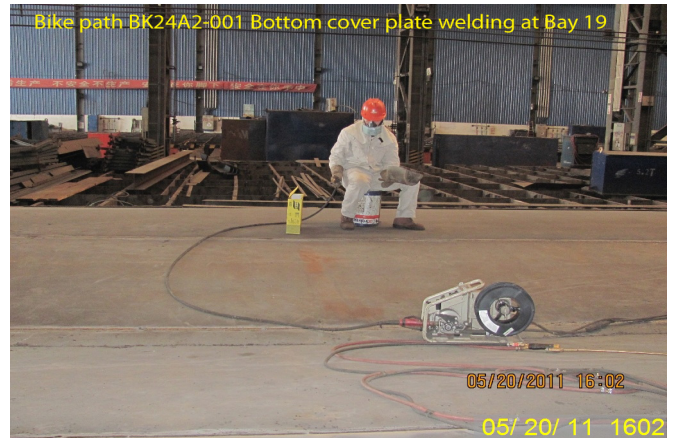
For further information see below pictures:-

Unless otherwise noted, all work observed on this date appeared to be in general compliance with the applicable contract documents.
